SMART COIL TUBING INSPECTION TECHNOLOGY (SCIT) USING SMART SENSORS, IMAGE PROCESSING & ARTIFICIAL INTELLIGENCE (AI)

ABSTRACT-

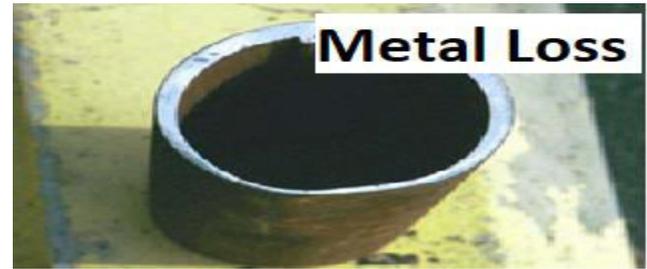
Figure 8. Example of Metal Loss

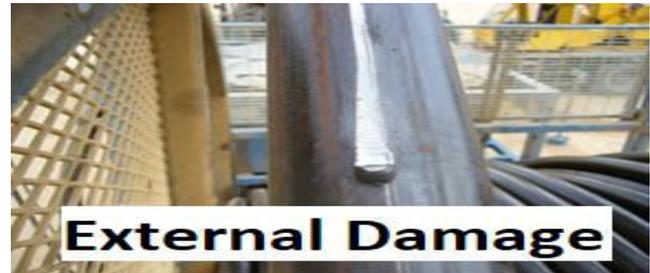
Figure 9. Example of External Damage

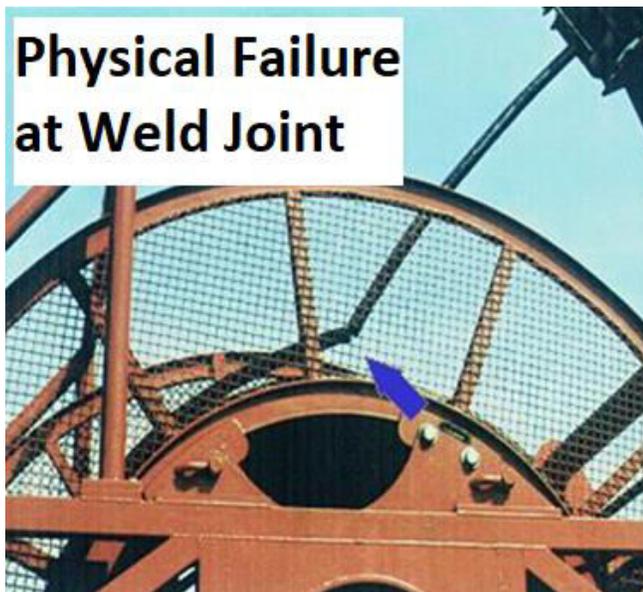
Figure 6. Failure due to Physical Failure at Weld Joint

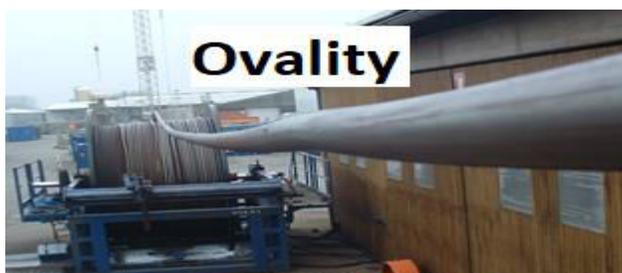
Figure 7. Example of Ovality

The ovality of the coil tubing is calculated from the measured minimum and maximum outer diameter of the CT by the following formula,

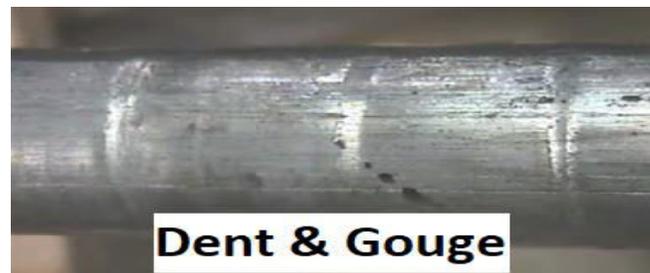
Figure 11. Example of Dent & Gouge

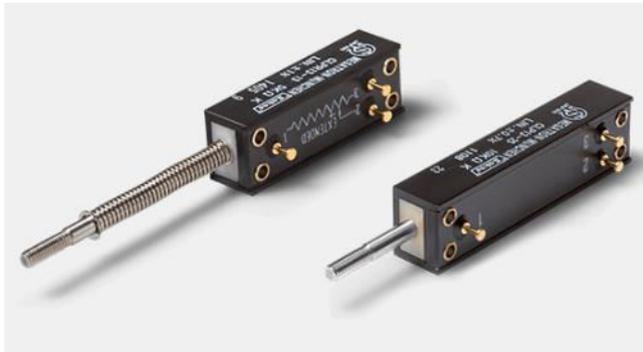
Caliper Sensors, potentiometric Linear Transducer CLP13 is used as displacement sensor in space-saving design & front guided push rod for 13mm to 100mm strokes. CLP13 is almost infinite resolution, space saving, compact design, robust with long lifetime ideal application in harsh environment such as Oil & Gas industries.

Figure 15. Potentiometer used as Caliper Sensor

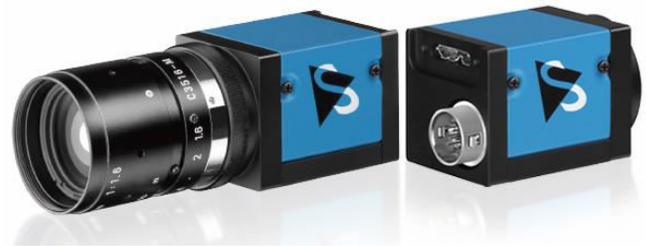
Excellent Image Quality & Great Performance. The Imaging Source USB 3.0 industrial cameras are best known for their excellent image quality, great performance and extremely competitive price. The USB 3.0 industrial cameras ship with very sensitive CCD or CMOS sensors from Sony which provide outstanding image quality and accuracy in color

reproduction, even under the harshest lighting conditions. They feature a variety of input, output, strobe, and trigger options via an external Hirose port. With their high-speed interface, the USB 3.0 industrial cameras deliver up to 120 images per second. Thanks to the integrated binning feature, the USB 3.0 industrial cameras merge pixels together to increase sensitivity. They output only a region of interest (ROI) and thus achieve a very high frame rate. The Imaging Source USB 3.0 industrial cameras the perfect solution for small device construction and the most demanding applications.

Figure 16. USB Camera
